## **Background**

The Retention pond is located on the north-east of the property. It is designed to temporarily detain storm water to meet water quantity criteria before discharging off the property.

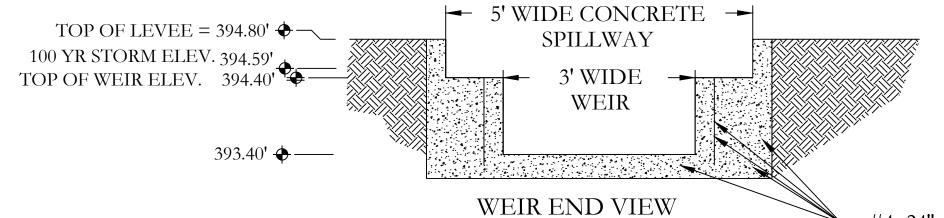
NTS

TOP OF LEVEE 5' WIDE TOP OF LEVEE = 394.80' -**GRASS** 100 YR STORM ELEV. 394.59' ◆-3:1 SLOPE #4- 24" c/c WEIR CROSS SECTION BOTTOM
